# BOWERS DAM

## NH 00330

### PHASE I INSPECTION REPORT

MAY 1980

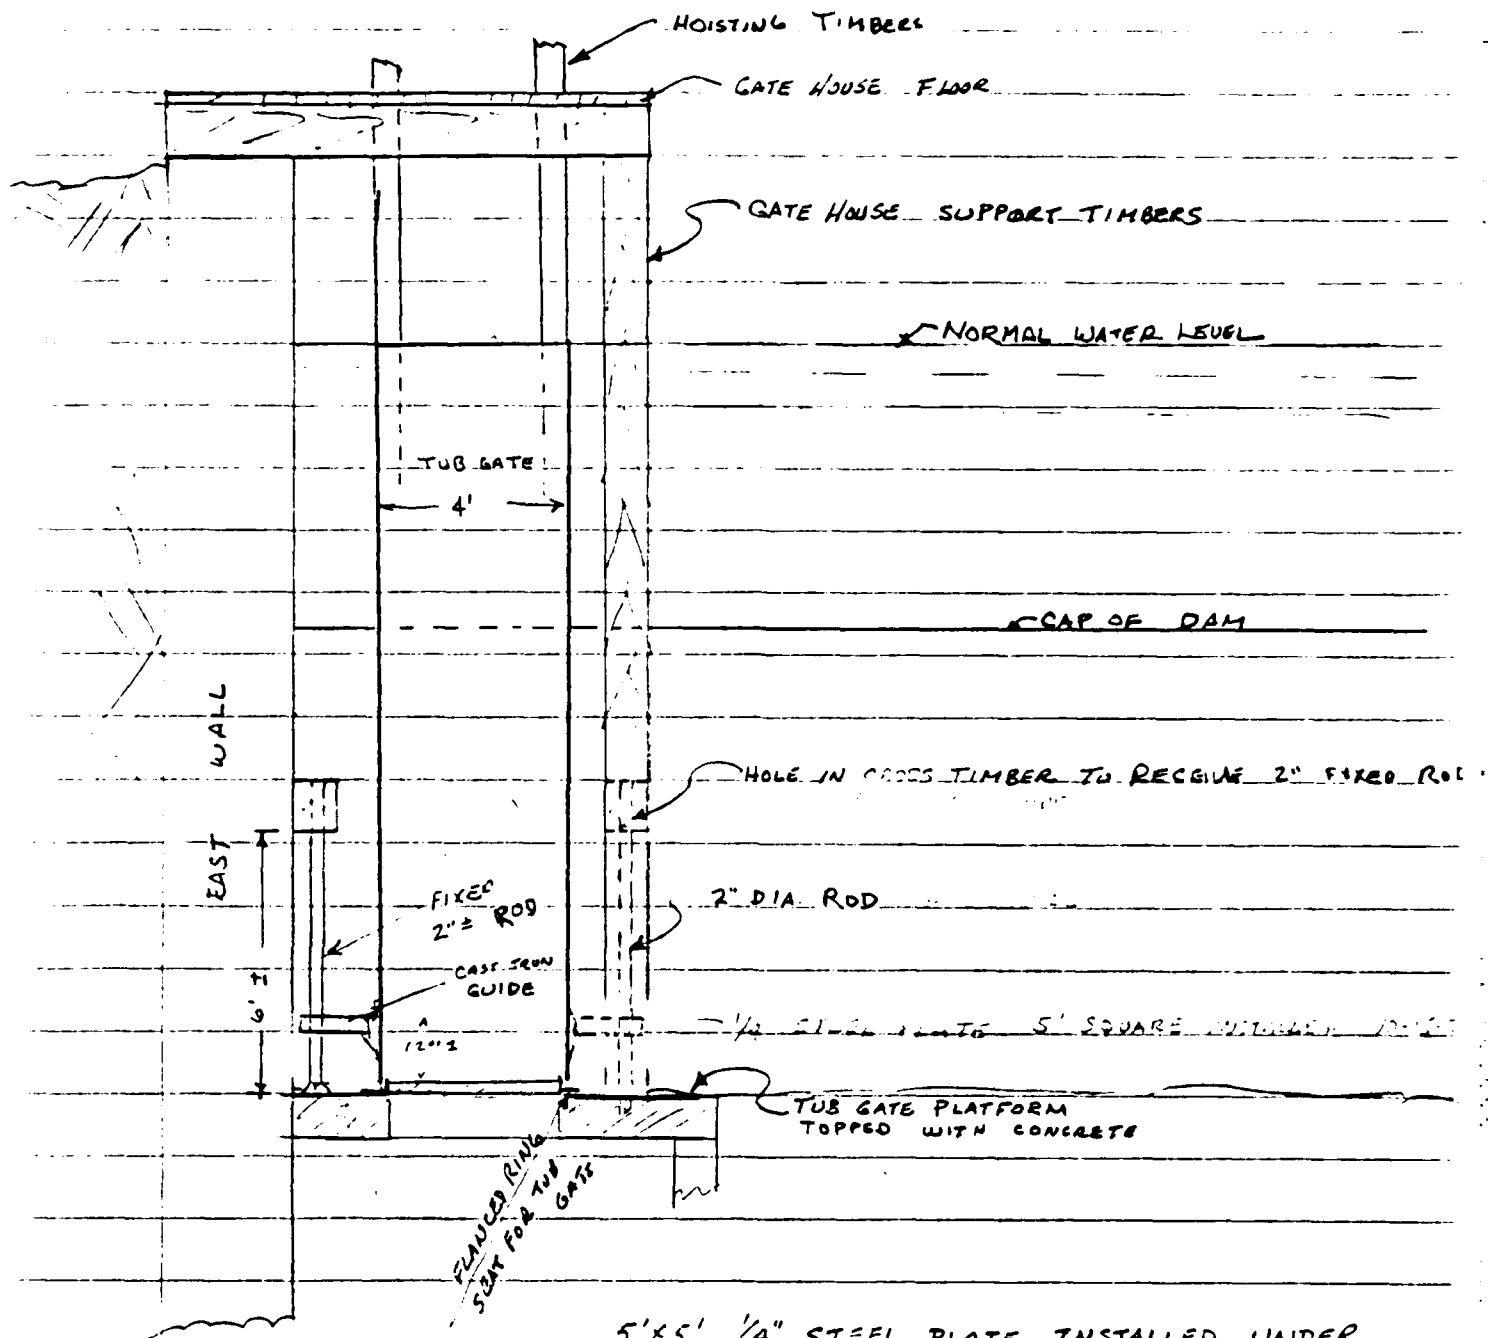
DRAWING OF TUB GATE AT BOWERS DAM - DEWATERED  
PLANKING REPLACED

5'x5' 1/4" STEEL PLATE INSTALLED UNDER

TUB GATE TO CLOSE OPENING. TUB GATE IS

BADLY RUSTED WITH HOLES IN IT RANGING

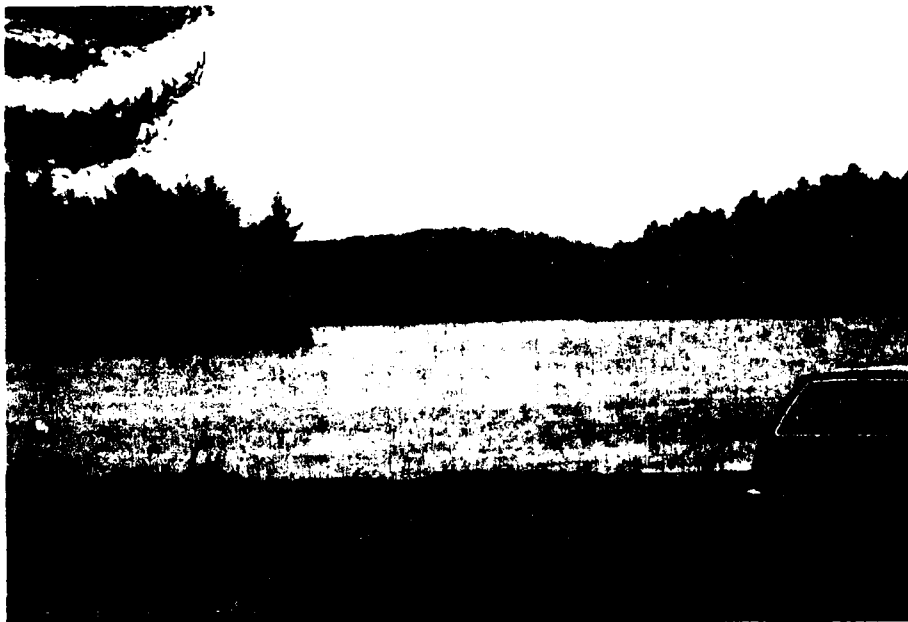
Photo No. 1 - General view of pond from dam.

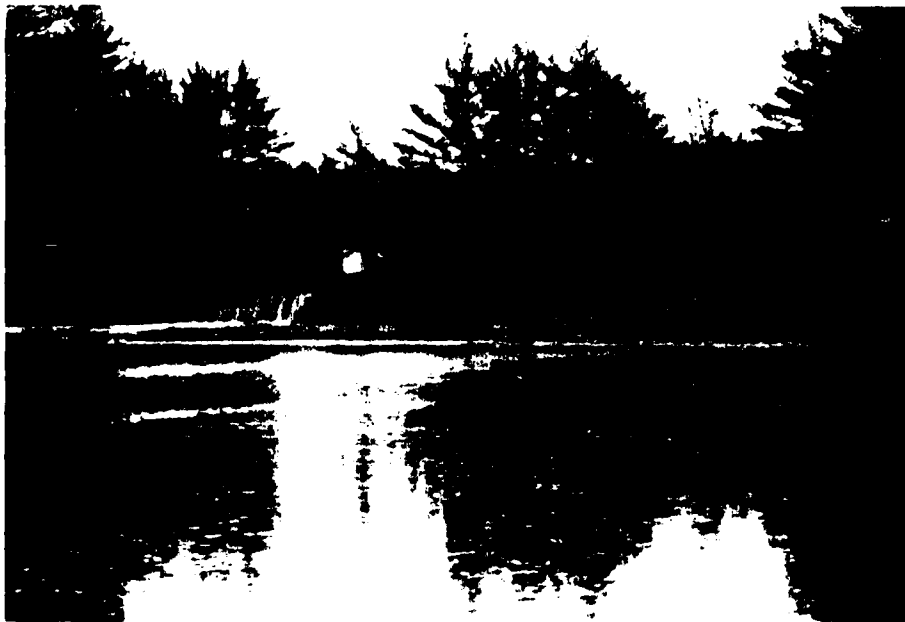
Photo No. 8 - View of downstream face of dam.

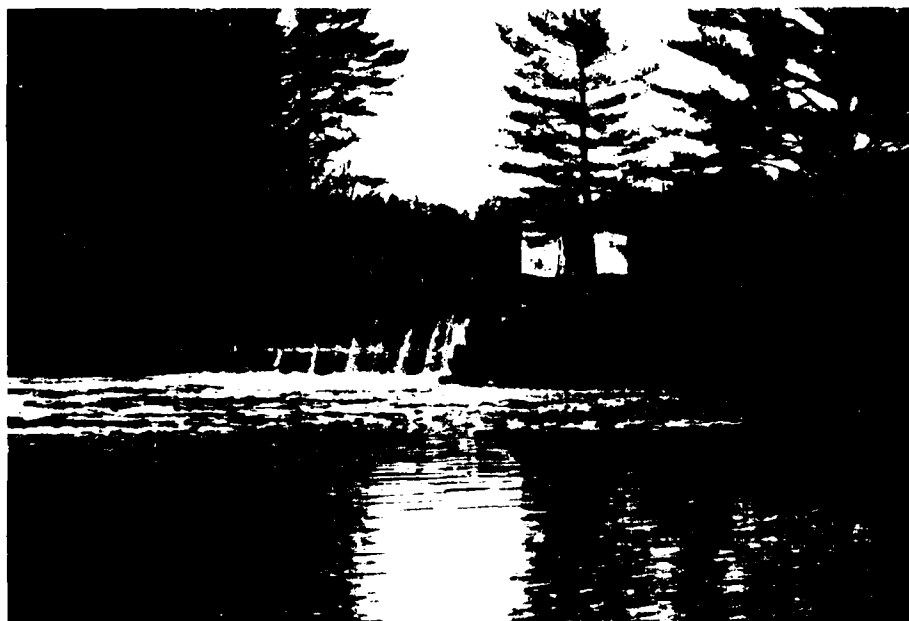
Photo No. 9 - View of downstream face of spillway structure.

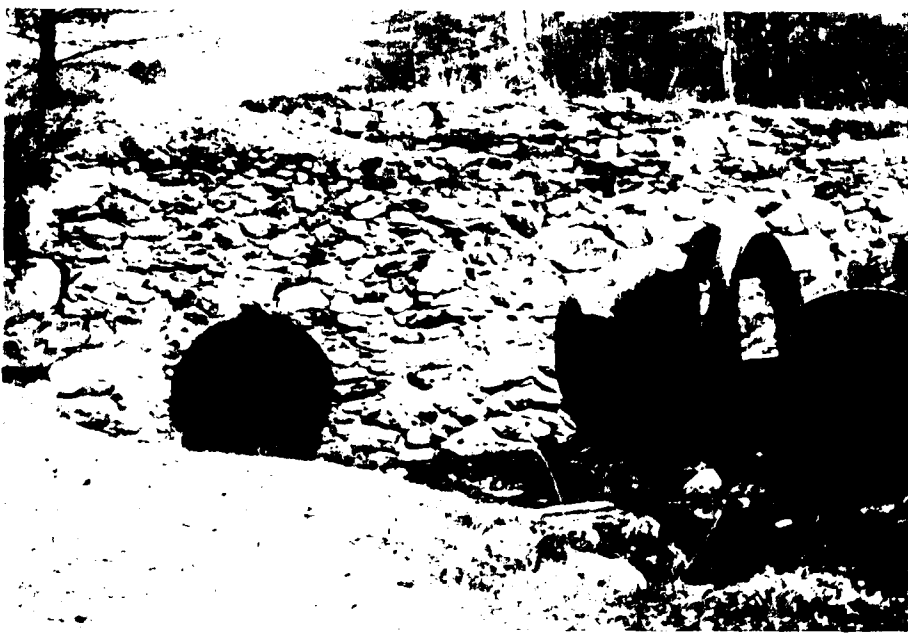
Photo No. 11 - View of downstream face of penstock outlet.

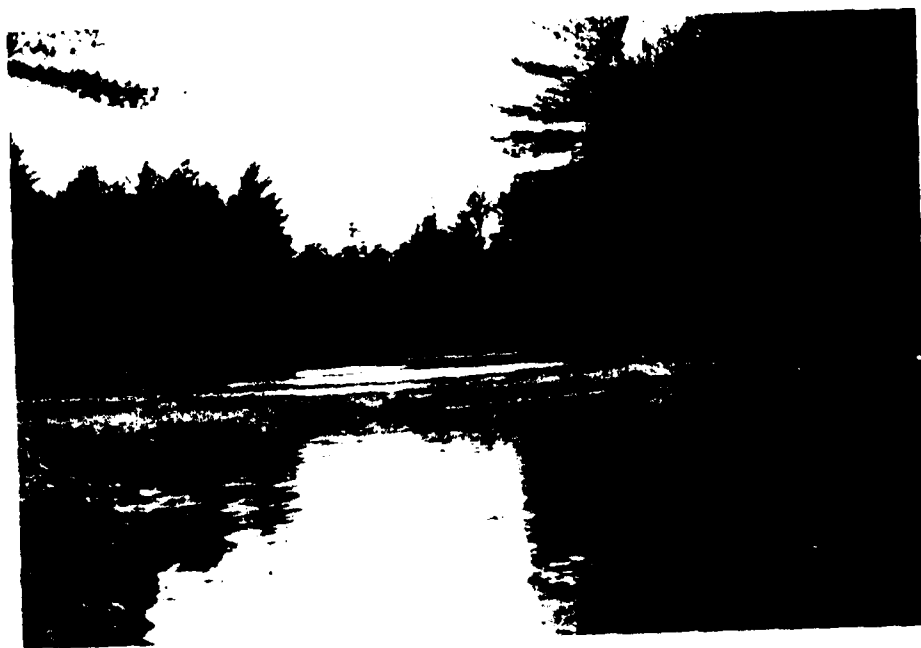
Photo No. 14 - View of downstream pond from dam.

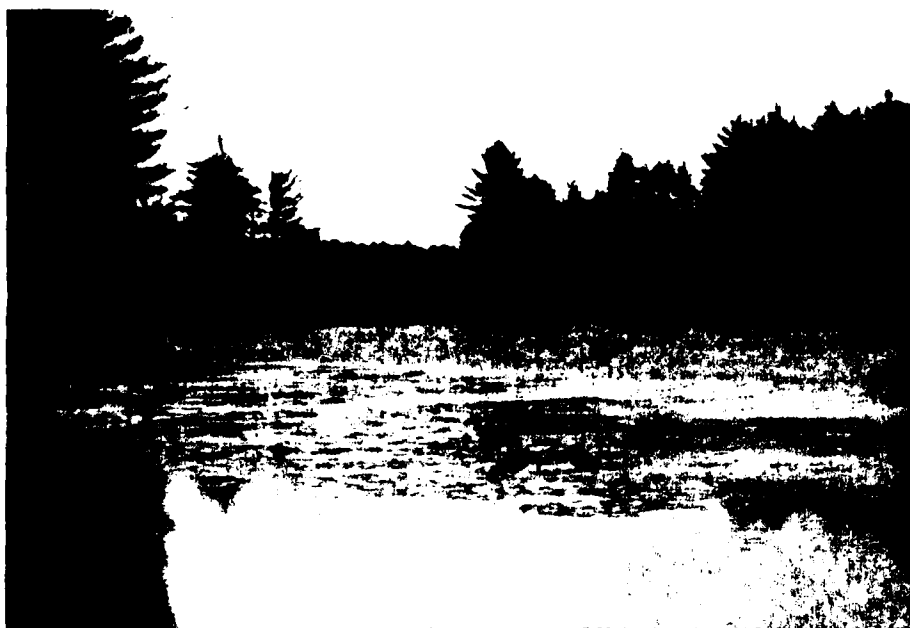
Photo No. 15 - View of downstream pond and roadway culvert.
